# PANGUNA MINE LEGACY IMPACT ASSESSMENT **PREPARATORY PHASE**

754-MELEN291242\_R01

29 MARCH 2022

PANGUNA MINE  
LEGACY IMPACT ASSESSMENT  
OVERSIGHT COMMITTEE

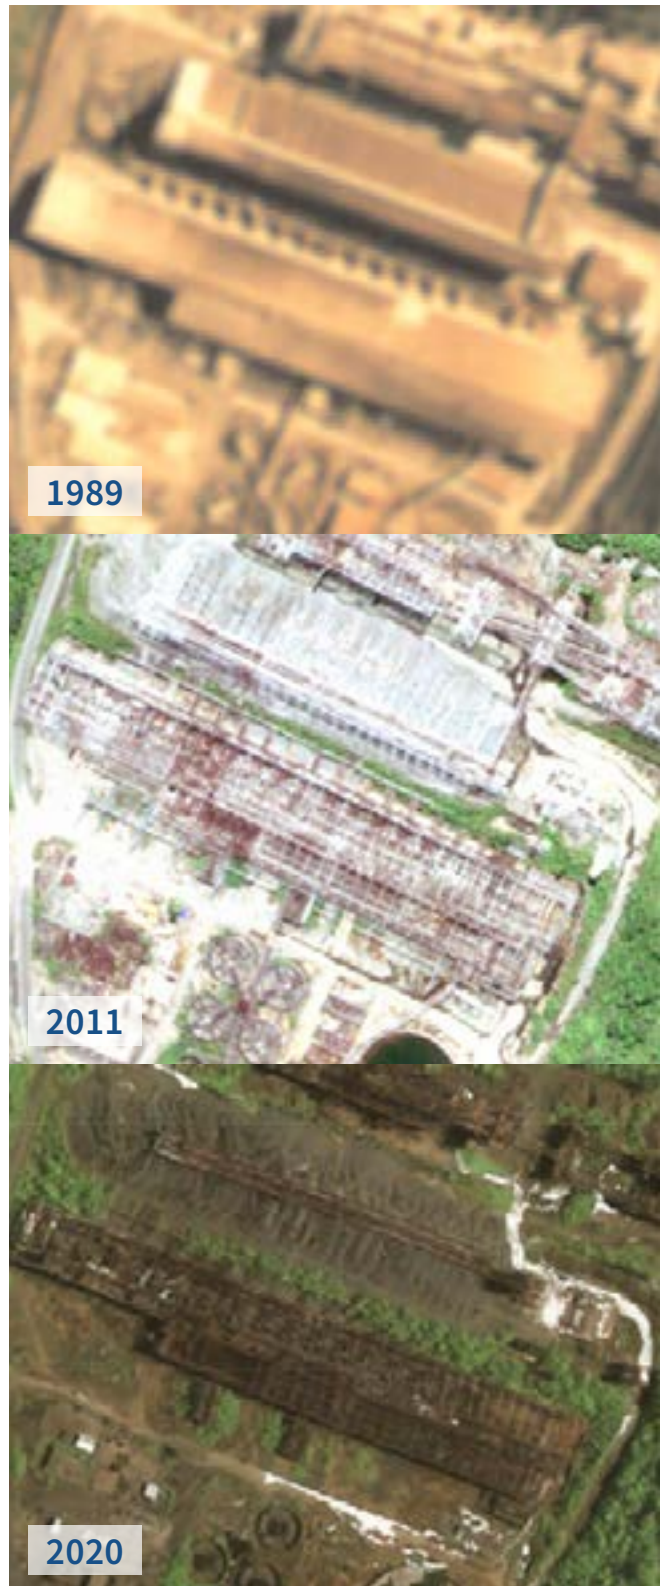
As could be expected, mine and process infrastructure appears in significantly worse condition in 2020 compared to its condition when operations stopped in 1989, as can be seen in the aerial photos from 1989, 2011 and 2020 of the concentrator at the process plant (Plate ES1).

**Plate ES1** Infrastructure deterioration at the concentrator at the process plant

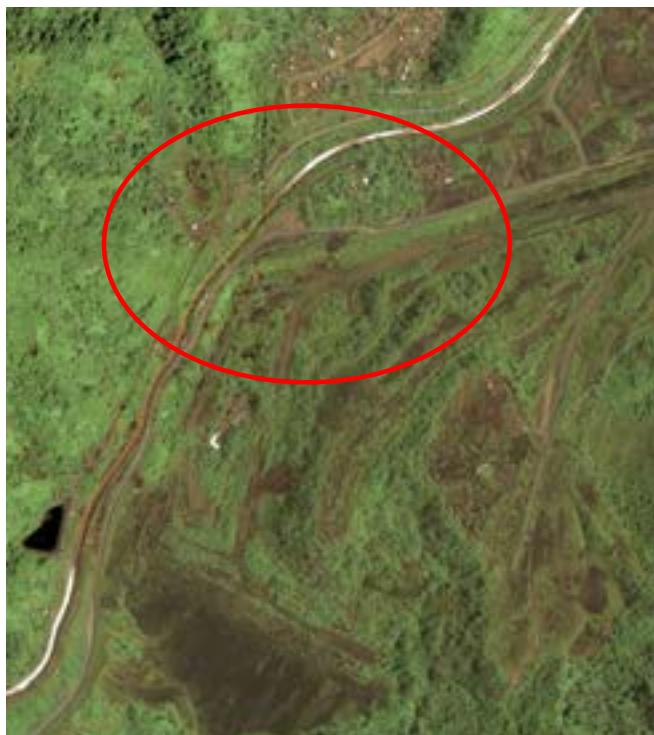
The condition of mine and process infrastructure, post 1989, is in stark contrast to the apparent condition of structures within the relocated village of Dapera, as well as the Arawa townsite, where, while some changes are evident over time, the structures appear to have been maintained in relatively good condition. Evidence of new construction was also observed in some areas of the Preparatory Phase Study Area when comparing images from 2011 to 2020, for the Panguna townsite, waste rock dump (Plate ES2) and Loloho Port.

**Plate ES2** Structures constructed at the waste rock dump since 2011

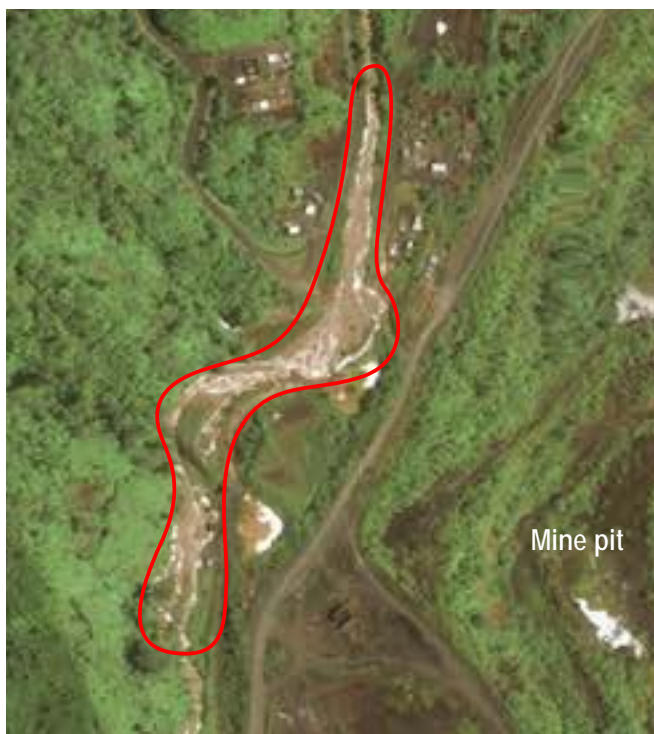
Infrastructure deterioration is evident in non-structural features such as the North Channel Diversion, which was built between 1976 and 1979 to divert the Upper Kawerong River flows from the waste rock dumps. The North Channel Diversion now appears to be full of sediment in 2020 aerial images (Plate ES3). The level of risk associated with sediment accumulation within the North Channel Diversion cannot be quantified currently because of the lack of topographic data.

**Plate ES3** North Channel Diversion full of sediment from watershed erosion

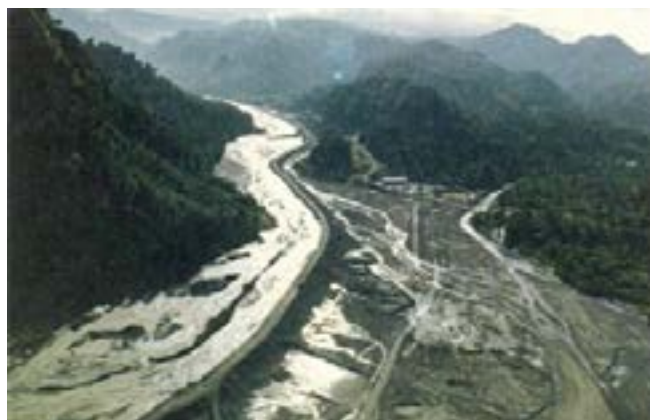
Plate ES4 shows the levee constructed at the junction of the Kawerong and Jaba rivers, referred to as the Main/Pump Station Levee.

**Plate ES4** Levee at Kawerong-Jaba river junction looking upstream, 1981

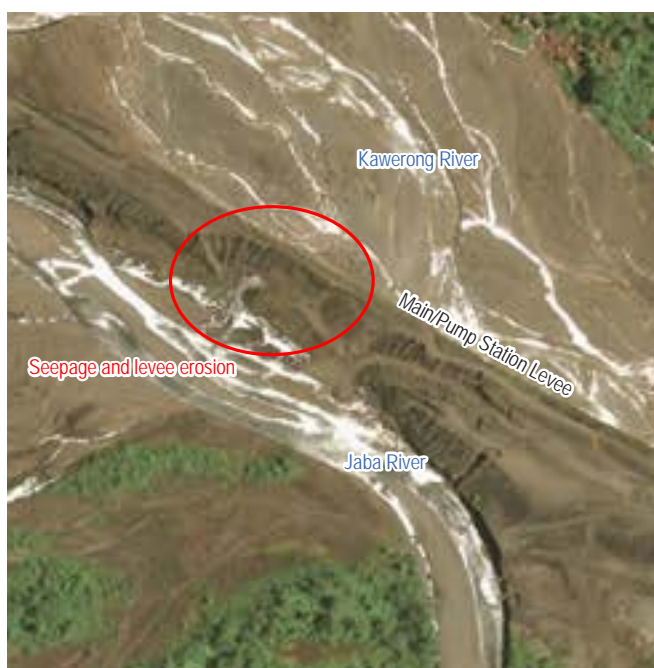
One of the most important parts of the Preparatory Phase assessment has been to try and assess the potential for levees to fail in the future. Aerial imagery, photographs and videos from 2019/2020 show that the levee at the junction of the Kawerong and Jaba rivers known as the Main/Pump Station Levee (Figure ES5) is almost certain to collapse at some stage in the future but when this will happen is unknown. Plates ES5a and 5b are images of this levee from 2020. In the image on the left hand side of the western end of the levee (Plate ES5a), erosion and seepage is visible in the red circle where the Jaba River is cutting into the south side of the levee and washing away sediment, which makes it less stable; water is flowing through the bottom of the levee.

**Plate ES5a** Seepage and levee erosion zone on western end of levee

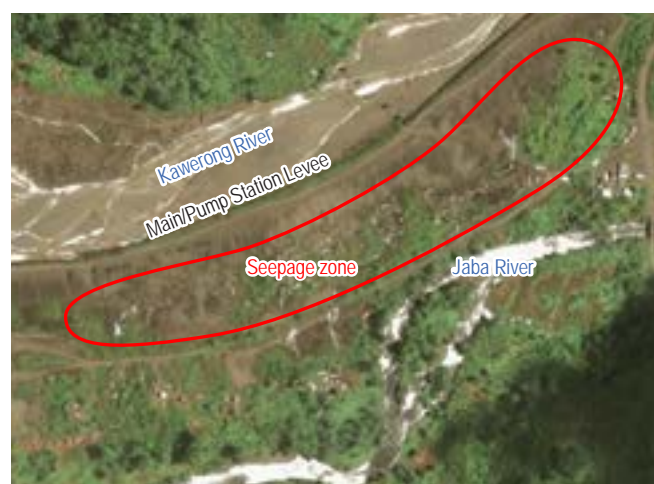
In the image on the right hand side (Plate ES5b), seepage is visible through the levee in the red outline where the Kaverong and Jaba rivers meet further upstream; the bed of the Kaverong River is about 10 m higher than the bed of the Jaba River.

**Plate ES5b** Seepage zone in the levee where the Kaverong and Jaba rivers meet

This levee may collapse due to flooding, earthquake, seepage or water flowing through tunnels which form under the levee wall. If the levee collapsed, structures and people that live on the floodplain downstream of the Jaba River would be directly impacted by flooding or landslide effect. The area inside the yellow line on Figure ES6a (view from the air) and Figure ES6b (view looking up the Kawerong River towards the Panguna mine) shows the area currently expected to be directly impacted if the levee collapses, and the orange colours show the groups of structures where people live. In addition to this, if the levee collapsed there would be an increase in erosion of the Kawerong River and more sediment would be transported into the Jaba River which could result in more flooding downstream.

- ▶ A site inspection and limited data collection to refine the assessment of the risk of failure of the Main/Pump Station Levee, including imminence of failure, the scope of more detailed investigations required and potential mitigation measures for failure.

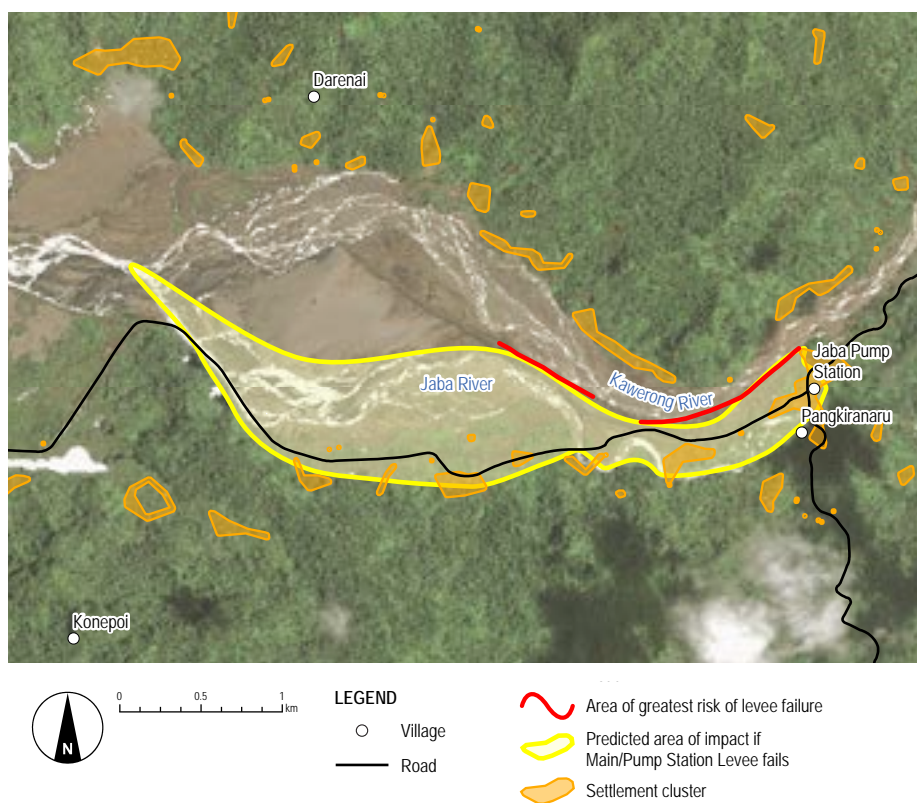
It is not yet possible to predict when the levee at the junction of the Kawerong and Jaba rivers may fail or how severe its failure may be due to limitations of current information. Further site assessments are required to better understand this risk and these will be a focus of the next phase of the Legacy Impact Assessment.

**Figure ES6a** View from the air of the levee at risk of failure (red line) and predicted area of direct impact (yellow line), showing groups of structures (orange) where people live

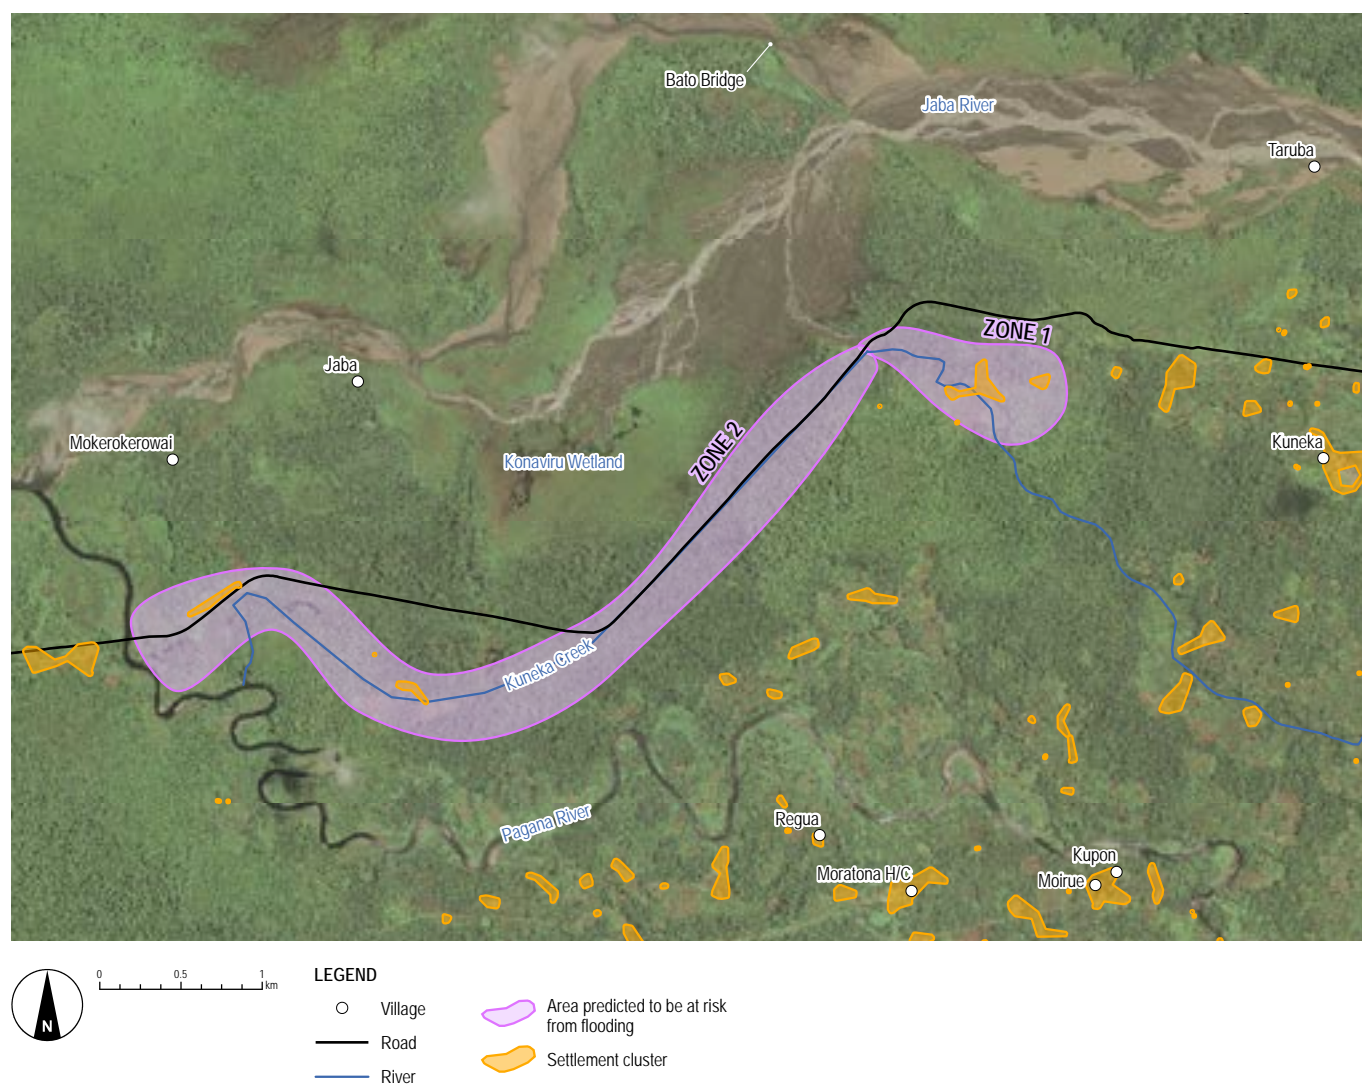
Build up of the river bed upstream of the Bato Bridge caused the Jaba River to change course in 2017 and start to flow into the Konaviru wetland and lower Kuneka Creek (Figure ES7), changing their flooding patterns and depositing tailings into them.

Based on assessment of 2020 aerial imagery, this change of flow into Konaviru wetland is likely to remain and become the focus of further tailings deposition in future. Figure ES7 shows the risk of flooding from the change in river course to the south of the Jaba River into the Konaviru wetland, with the currently expected area of direct impact from flooding shown in the purple line and groups of structures where people live shown in orange.

**Figure ES7** Area of flooding risk to nearby structures and people with the predicted area of direct impact (purple line), showing groups of structures (orange) where people live

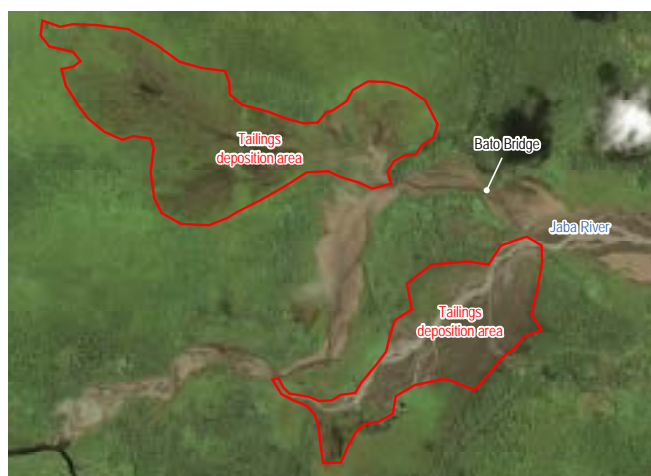
Raising of the bed of the Jaba River downstream of Bato Bridge before 2011 caused water to flow over the natural levee along the side of the river and a break to form in the natural levee. This led to flooding and deposition of tailings into a low area on the north side of the river, which had affected about 400 ha by 2020 (Plate ES6). The break in the levee is still open, and the low area is likely to continue receiving tailings, unless the change in the direction of the Jaba River described below separates that section of the river.

**Plate ES6** Indicative existing flooding and tailings deposition areas to the north (downstream of Bato Bridge) and south (upstream of Bato Bridge) of the Jaba River

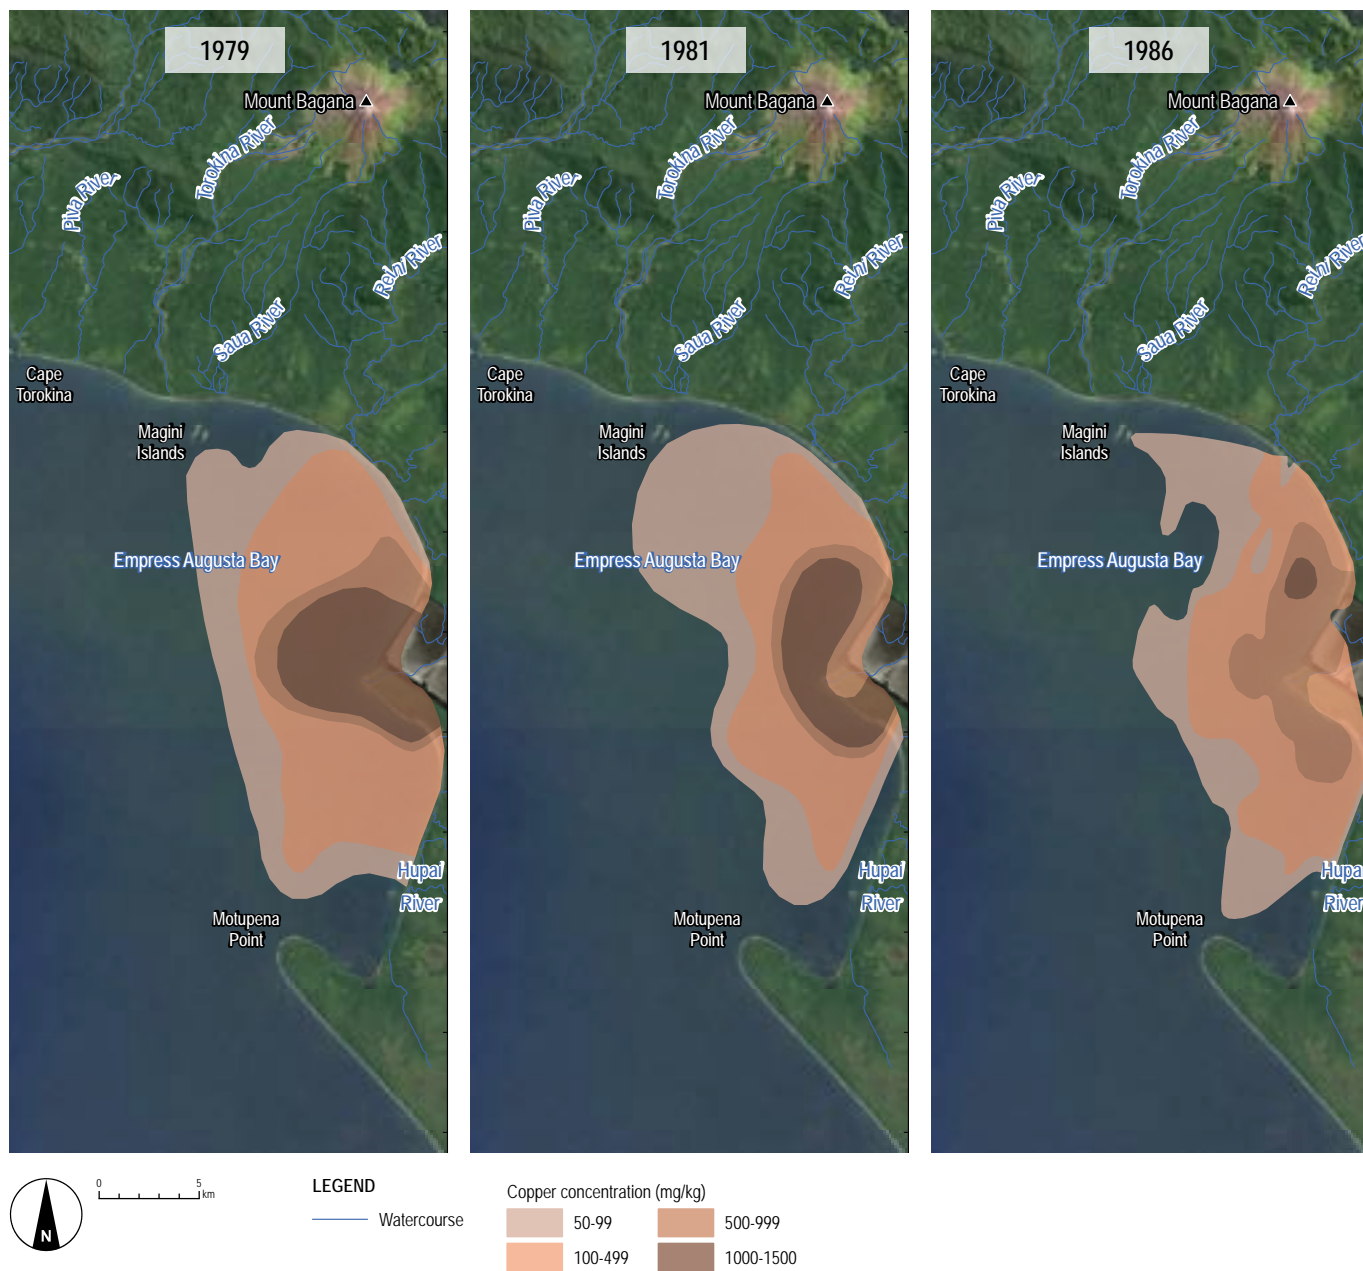
Between 50 and 60% of the Empress Augusta Bay seabed was contaminated with tailings to some extent between 1979 and 1986. Figure ES12 shows the area of the floor of Empress Augusta Bay contaminated by tailings in 1971 (left), 1981 (middle) and 1986 (right). The darker brown colour shows the higher concentration of copper: the area of dark brown (high copper concentration) appears to gradually reduce from 1979 to 1986 but it is not known if this trend has continued.

**Figure ES12** Contamination of the seabed in Empress Augusta Bay in 1971, 1981 and 1986
