PANGUNA MINE LEGACY IMPACT ASSESSMENT PREPARATORY PHASE

Summary

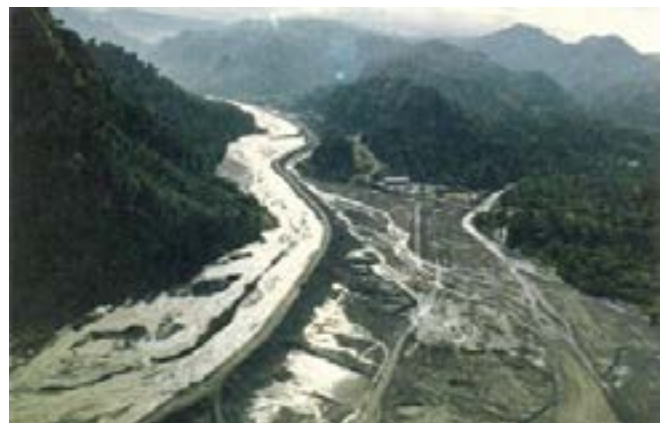
Plate 1 Levee at Kawerong-Jaba river junction looking upstream, 1981

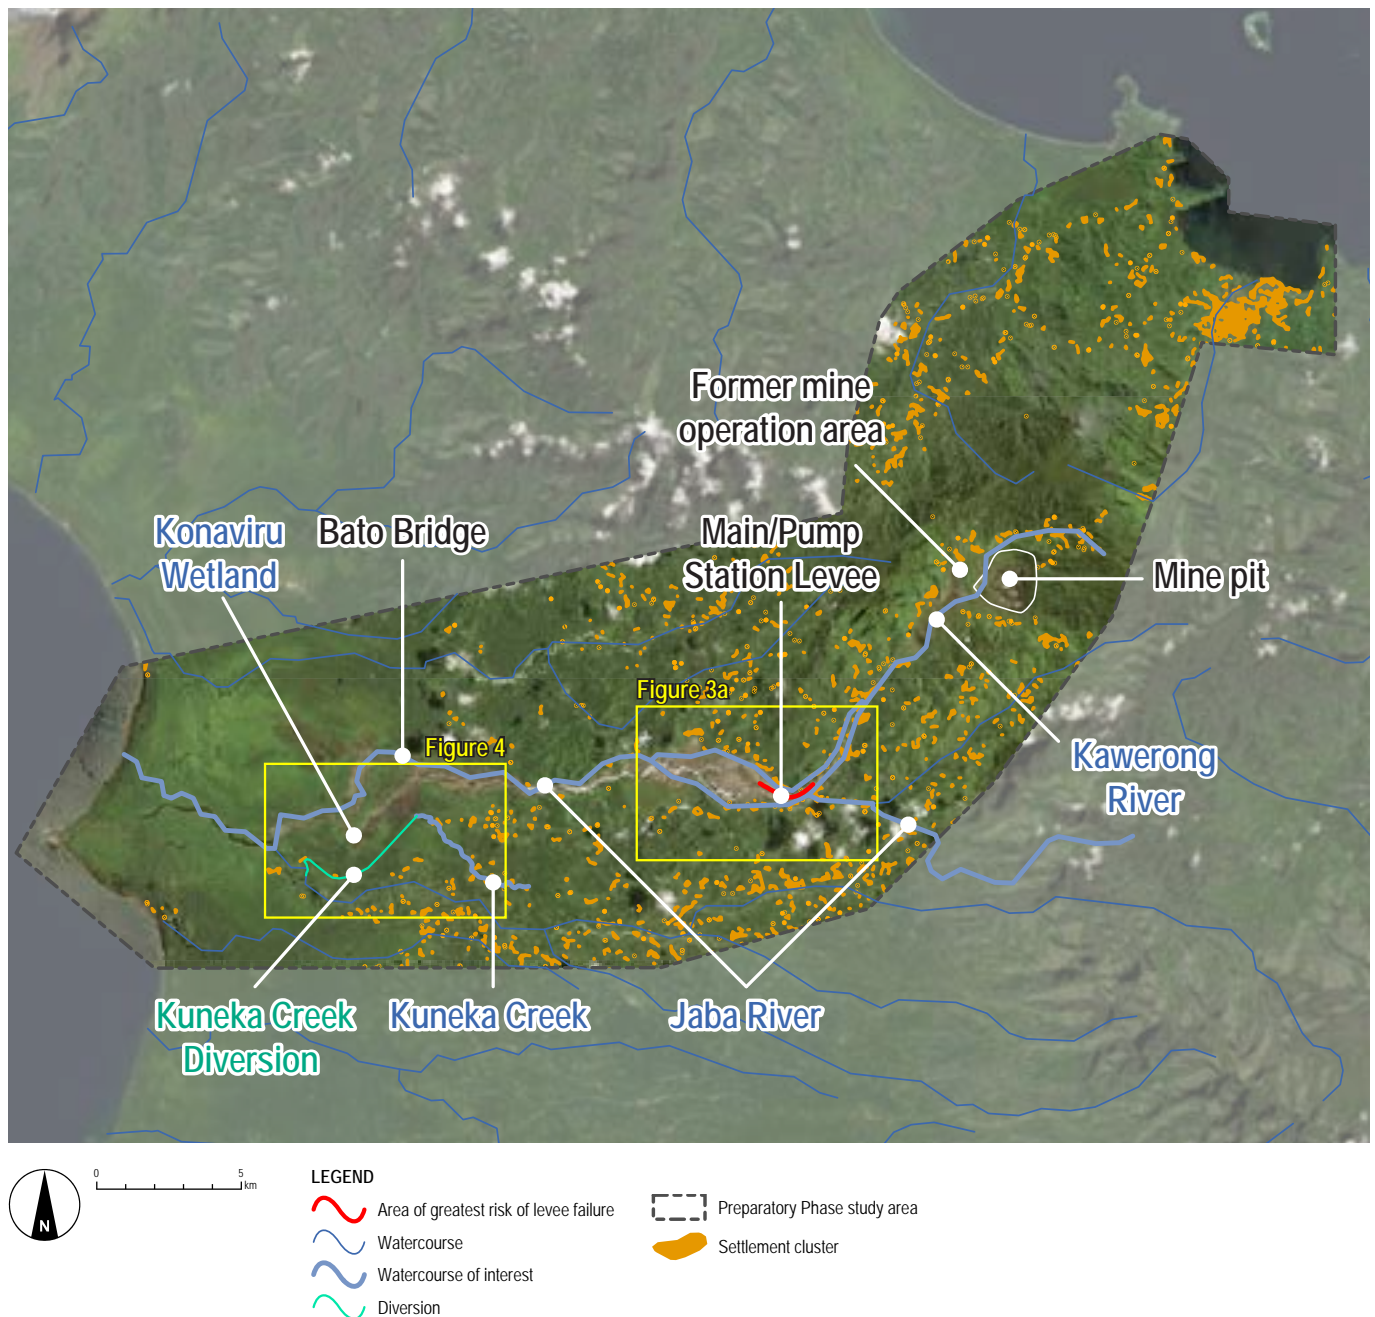
Figure 2 Location of the levee at the junction of the Kaverong and Jaba rivers

One of the most important parts of the Preparatory Phase assessment has been to try and assess the potential for levees to fail in the future. Aerial imagery, photographs and videos from 2019/2020 show that the levee at the junction of the Kaverong and Jaba rivers known as the Main/Pump Station Levee (Figure 2) is almost certain to collapse at some stage in the future but when this will happen and how severe the impact would be is unknown. This may happen due to flooding, earthquake, seepage or water flowing through tunnels which form under the levee wall. If the levee collapsed, structures and people that live on the floodplain downstream of the Jaba River would be directly impacted by flooding or landslide effect.

It is not yet possible to predict when the levee at the junction of the Kawerong and Jaba rivers may fail or how severe its failure may be due to limitations of current information. Further site assessments are required to better understand this risk and these will be a focus of the next phase of the Legacy Impact Assessment.

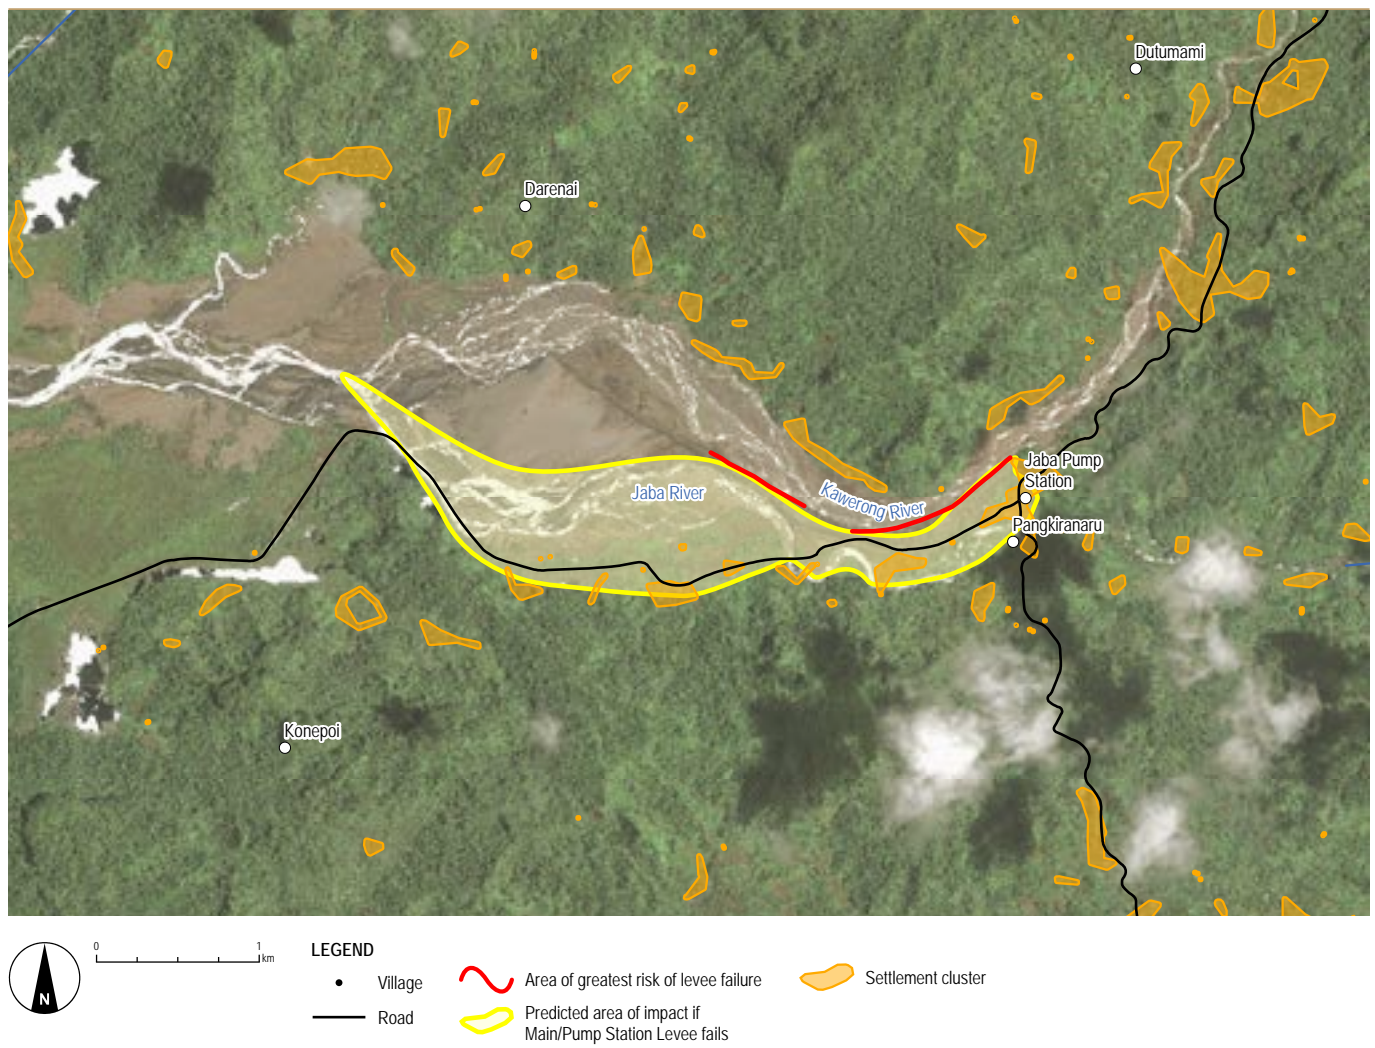
Figure 3a View from the air of the levee at risk of failure (red line) and predicted area of direct impact (yellow line), showing groups of structures (orange) where people live

The yellow line on Figure 3a (view from the air) and Figure 3b (view looking up the Kawerong River towards the Panguna mine) shows the area currently expected to be directly impacted if the levee collapses, and the orange colours show the groups of structures where people live. There are estimated to be 85 dwelling structures in this predicted area of direct impact, with a potential population of approximately 370 people, conservatively assuming all structures are occupied. In addition to this, if the levee collapsed there would be an increase in erosion of the Kawerong River and more sediment would be transported into the Jaba River which could result in more flooding downstream.

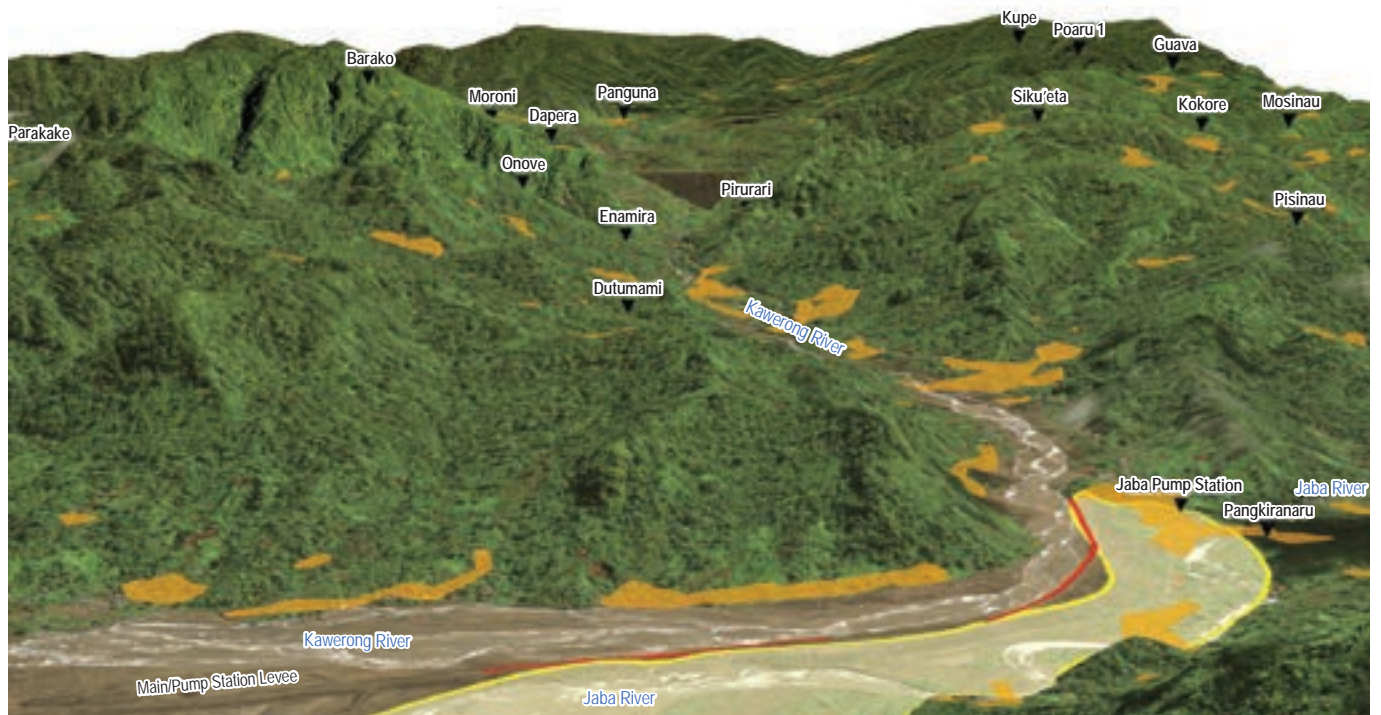
Figure 3b View looking up the Kawerong River towards the Panguna mine showing the predicted area of direct impact (yellow line) and groups of structures (orange) where people live

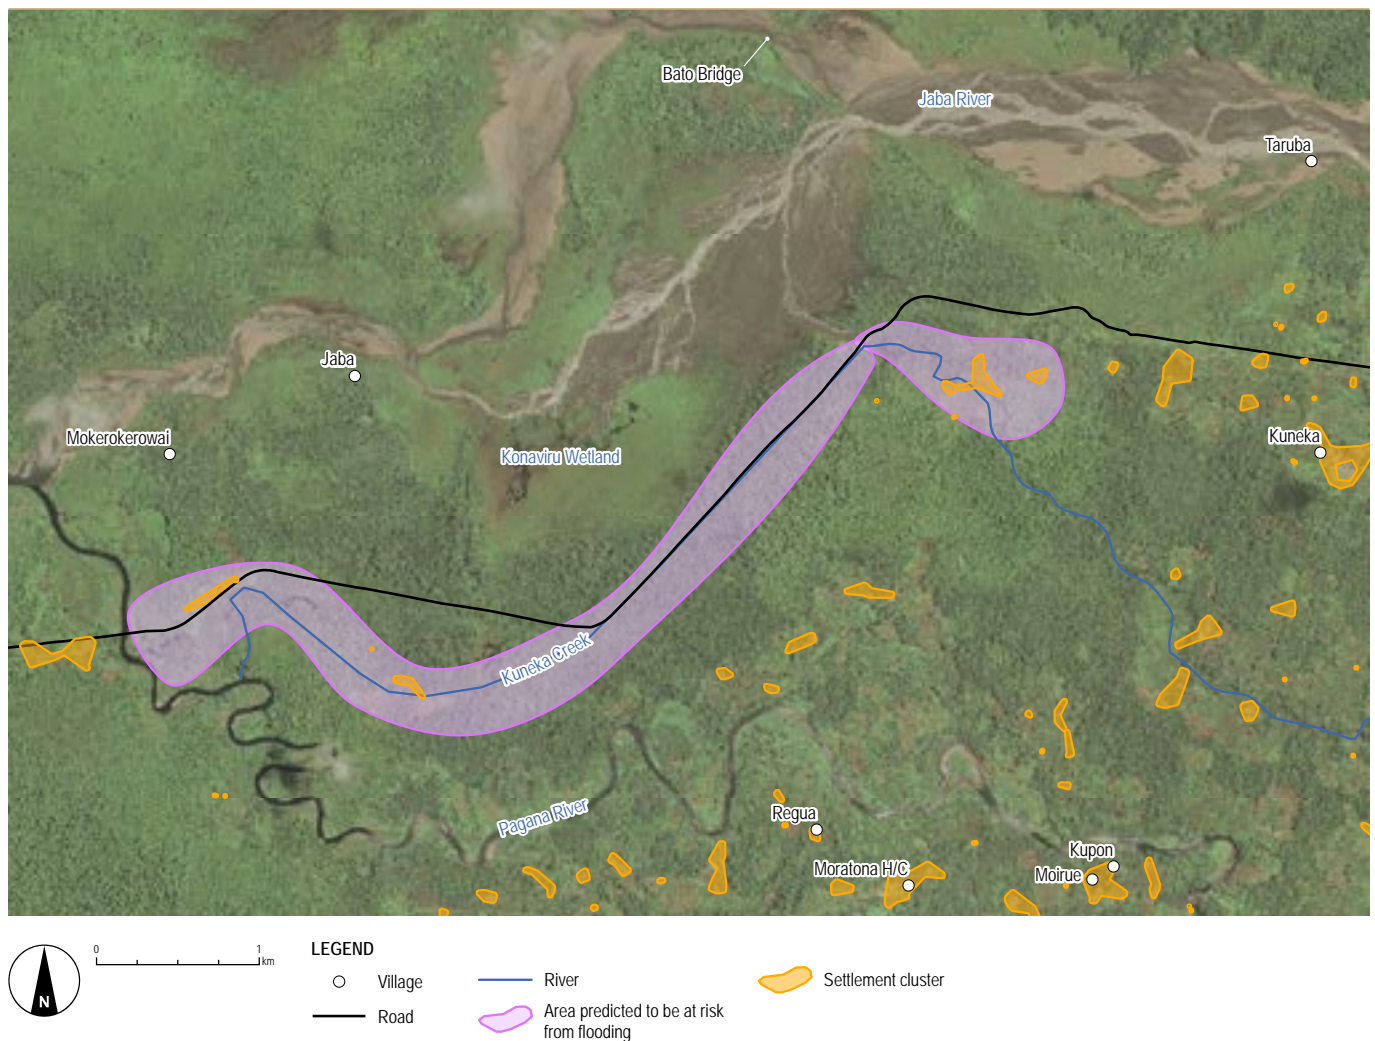
Figure 4 Area of flooding risk to nearby structures and people with the predicted area of direct impact (purple line), showing groups of structures (orange) where people live

Another important part of the Preparatory Phase assessment was to look at where flooding may occur in the future, particularly from changes in river flow due to movement of tailings down the river. The bed of the Jaba River has raised over time due to flooding and build-up of previously deposited tailings, such as at the lower Jaba River near Bato Bridge. In 2017, the Jaba River changed course and started to flow into the Konaviru wetland and lower Kuneka Creek (Figure 4), changing their flooding patterns and depositing tailings into them.

Based on assessment of 2020 aerial imagery, this change of flow into Konaviru wetland is likely to remain and become the focus of further tailings deposition in the future. Figure 4 shows the risk of flooding from the change in river course to the south of the Jaba River into the Konaviru wetland, with the currently expected area of direct impact from flooding shown in the purple line and groups of structures where people live shown in orange. There are estimated to be 50 dwelling structures in this predicted area of direct impact, with a potential population of approximately 200 people, conservatively assuming all structures are occupied.

It is not yet possible to predict when this will happen and whether the change will be permanent. Further site assessments are required to better understand this risk and these will be a focus of the next phase of the Legacy Impact Assessment.

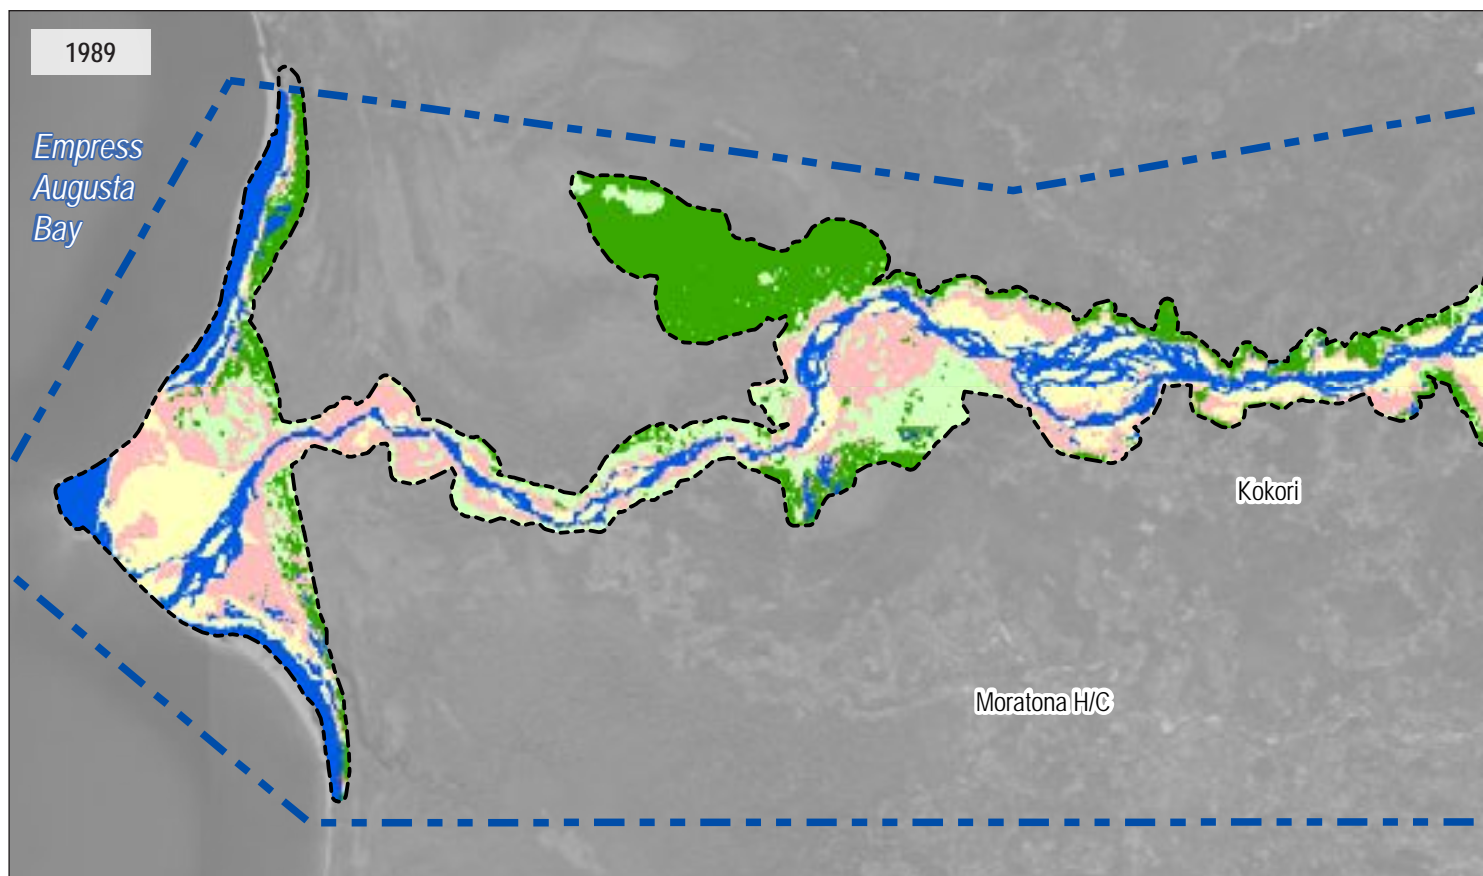
Figure 5 Landcover classification – Riverine footprint 1989

Figure 5 shows the landcover type for the riverine area in 1989. This shows large areas of sand (i.e., tailings) throughout the highly braided river system, little to no dense vegetation along the Jaba River, no tailings deposition in the area of dense vegetation north of the Jaba River downstream from Bato Bridge, no revegetation of the Jaba River Delta and very few settlements along the margins of the riverine footprint. In comparison, Figure 6 shows the landcover classification for the riverine area in 2021. This shows reduced areas of sand along the less braided river system with large areas that were sand in 1989 now being sparse or dense vegetation, conversion of the dense vegetation north of the Jaba River downstream from Bato Bridge into sparse vegetation and bare earth due to the deposition of tailings in this area, the change in the course of the Jaba River through the Konaviru wetlands, revegetation of most of the Jaba River Delta and more settlements along the margins of the riverine footprint, particularly along the north and south of the edge of the river near the Jaba Pump Station.

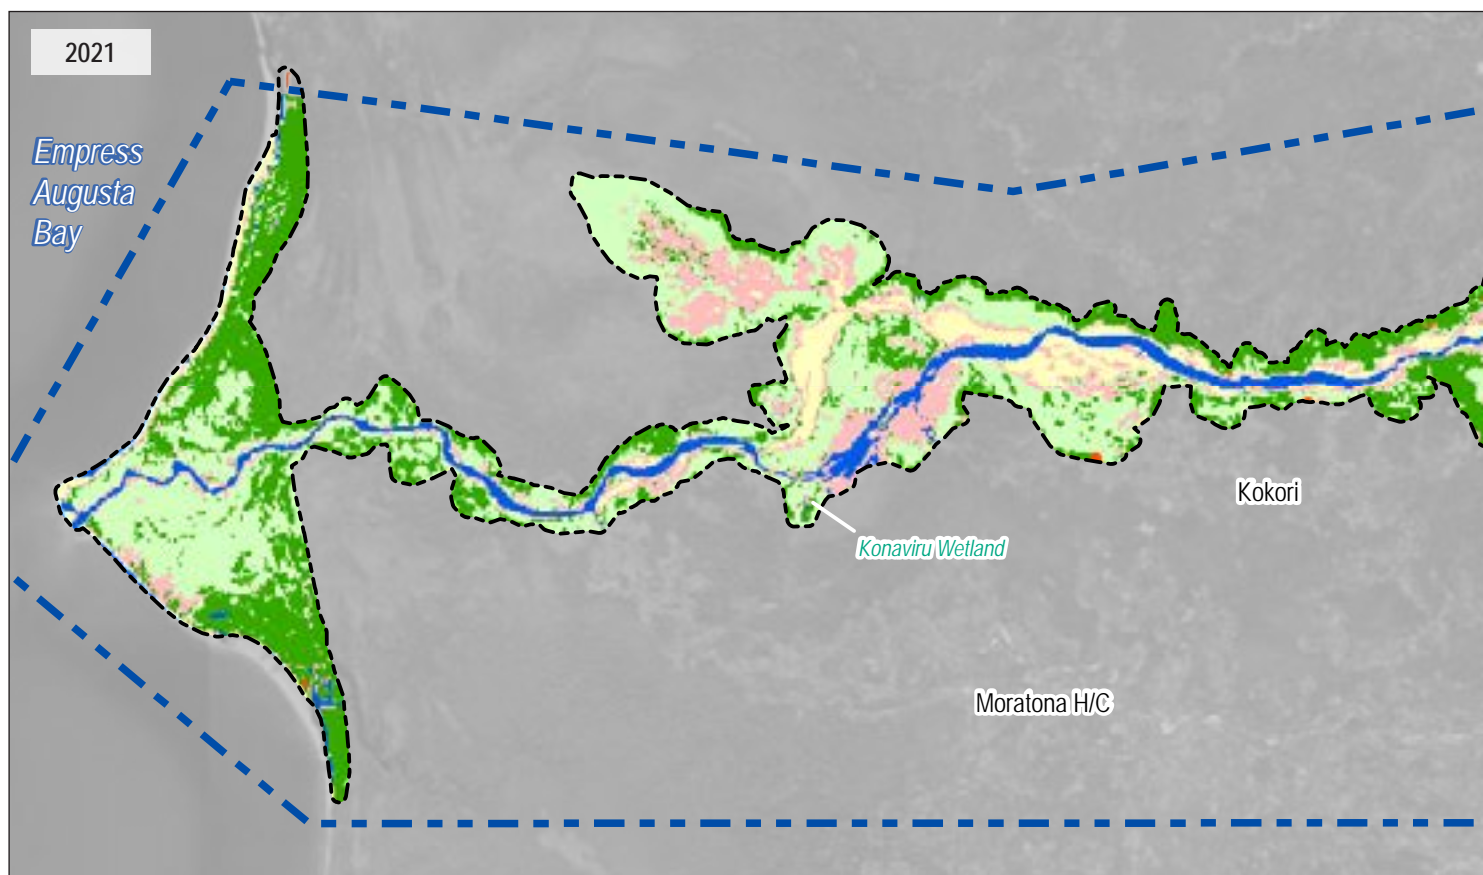
Figure 6 Landcover classification – Riverine footprint 2021

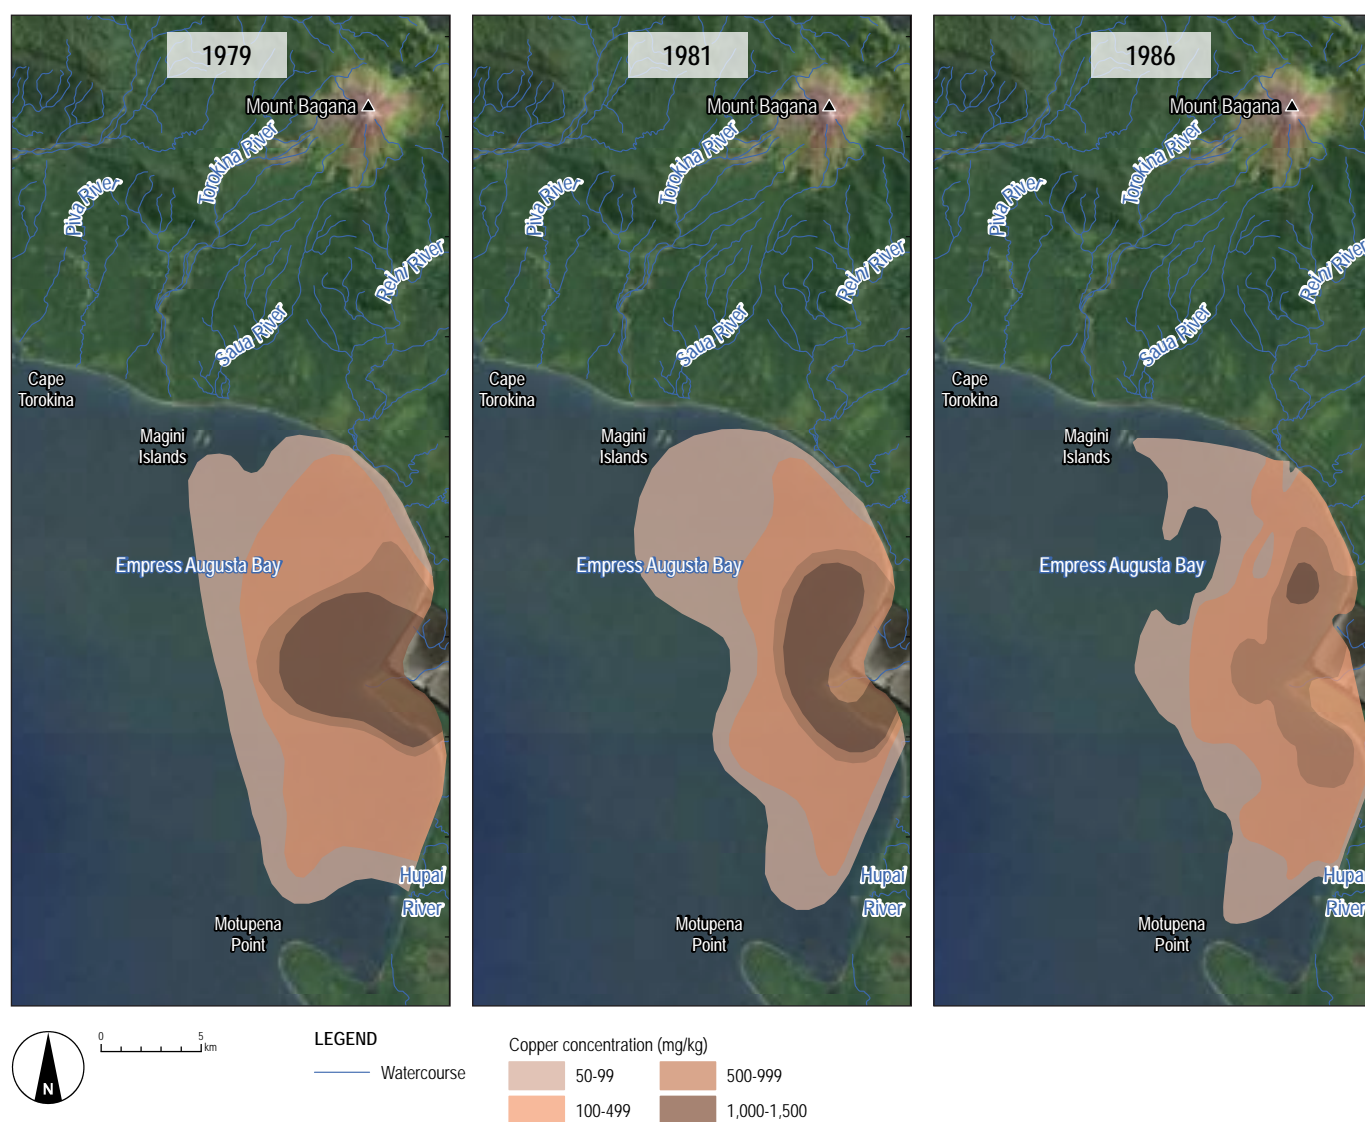
Sixty (60) percent of tailings discharged by the mine was washed into Empress Augusta Bay during operations. Between 50 and 60% of the Empress Augusta Bay seabed was contaminated with tailings to some extent between 1979 and 1986. Figure 7 shows the area of the floor of Empress Augusta Bay contaminated by tailings in 1971 (left), 1981 (middle) and 1986 (right). The darker brown colour shows the higher concentration of copper: the area of dark brown (high copper concentration) appears to gradually reduce from 1979 to 1986 but it is not known if this trend has continued.

Figure 7 Contamination of the seabed in Empress Augusta Bay in 1971, 1981 and 1986

The current area of contamination and its impact on marine ecology and marine resource use in Empress Augusta Bay is not known and will need to be determined during the Legacy Impact Assessment.
