# PANGUNA MINE LEGACY IMPACT ASSESSMENT **PREPARATORY PHASE**

754-MELEN291242\_R01

29 MARCH 2022

PANGUNA MINE  
LEGACY IMPACT ASSESSMENT  
OVERSIGHT COMMITTEE

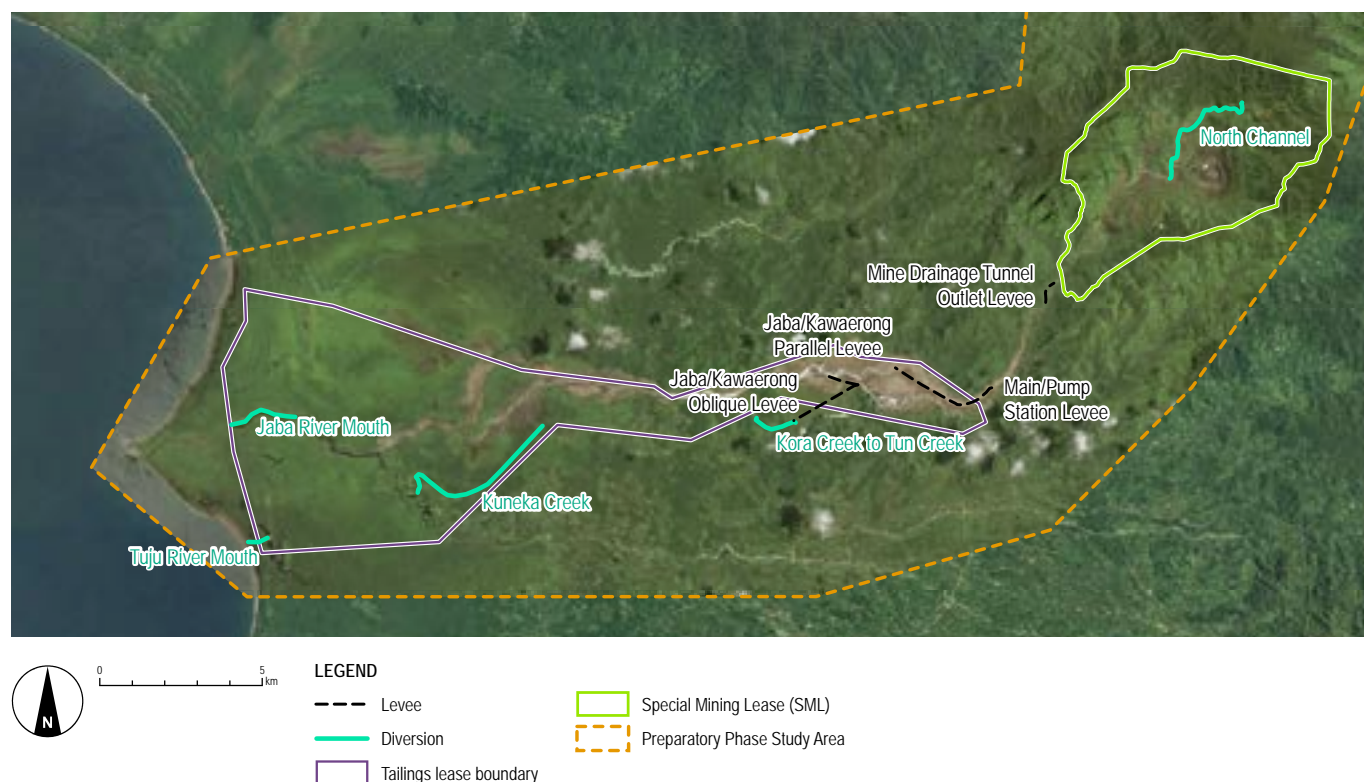
**Figure ES4** Location of river diversions (blue), levees (black) and Tailings Lease boundary (purple)

Infrastructure deterioration is evident in non-structural features such as the North Channel Diversion, which was built between 1976 and 1979 to divert the Upper Kawerong River flows from the waste rock dumps. The North Channel Diversion now appears to be full of sediment in 2020 aerial images (Plate ES3). The level of risk associated with sediment accumulation within the North Channel Diversion cannot be quantified currently because of the lack of topographic data.

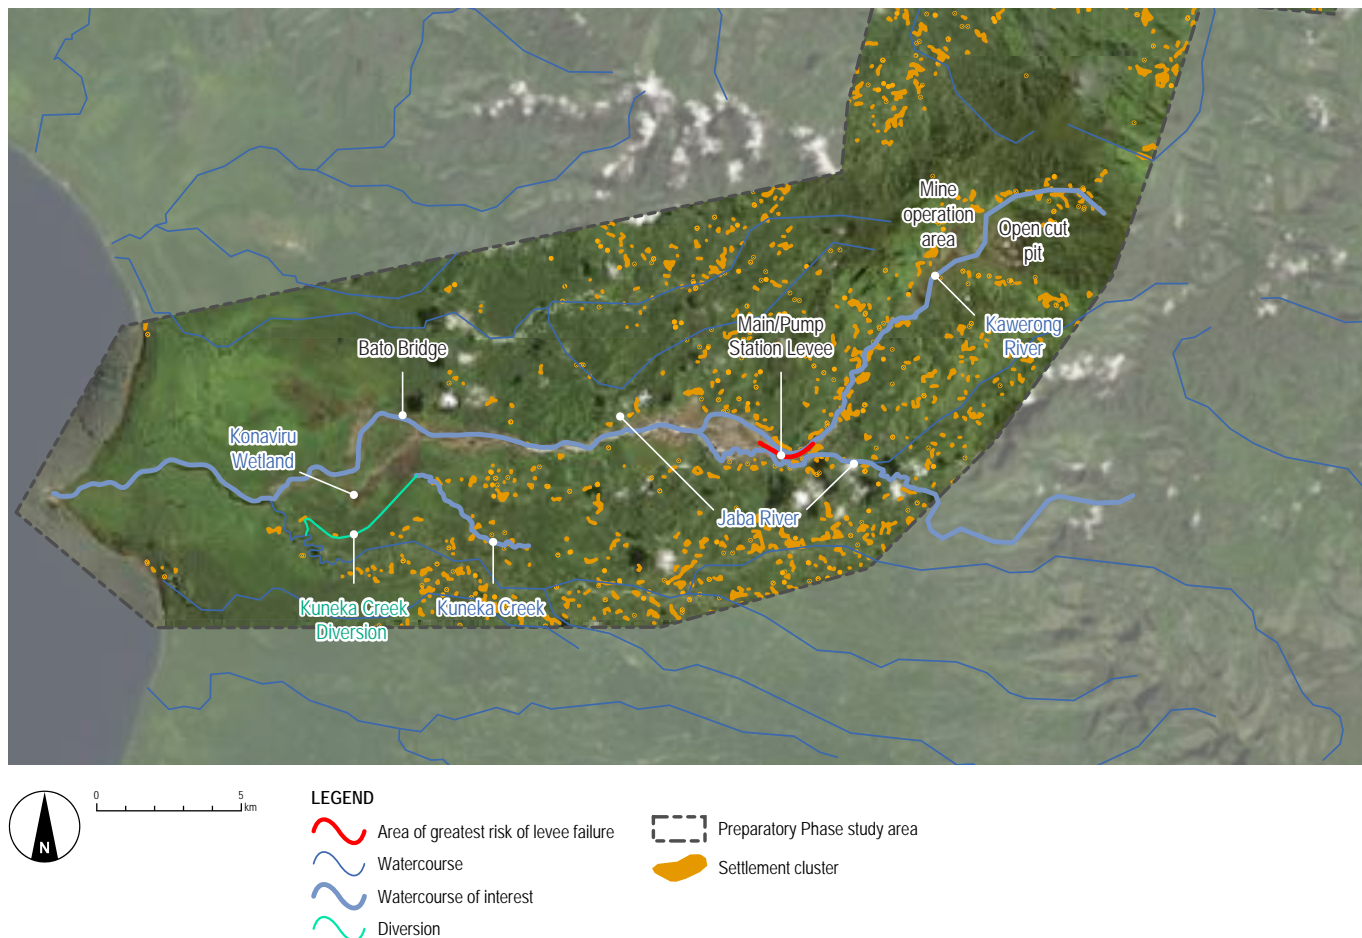
**Figure ES5** Location of the levee at the junction of the Kaverong and Jaba rivers

One of the most important parts of the Preparatory Phase assessment has been to try and assess the potential for levees to fail in the future. Aerial imagery, photographs and videos from 2019/2020 show that the levee at the junction of the Kawerong and Jaba rivers known as the Main/Pump Station Levee (Figure ES5) is almost certain to collapse at some stage in the future but when this will happen is unknown. Plates ES5a and 5b are images of this levee from 2020. In the image on the left hand side of the western end of the levee (Plate ES5a), erosion and seepage is visible in the red circle where the Jaba River is cutting into the south side of the levee and washing away sediment, which makes it less stable; water is flowing through the bottom of the levee.

It is not yet possible to predict when the levee at the junction of the Kawerong and Jaba rivers may fail or how severe its failure may be due to limitations of current information. Further site assessments are required to better understand this risk and these will be a focus of the next phase of the Legacy Impact Assessment.

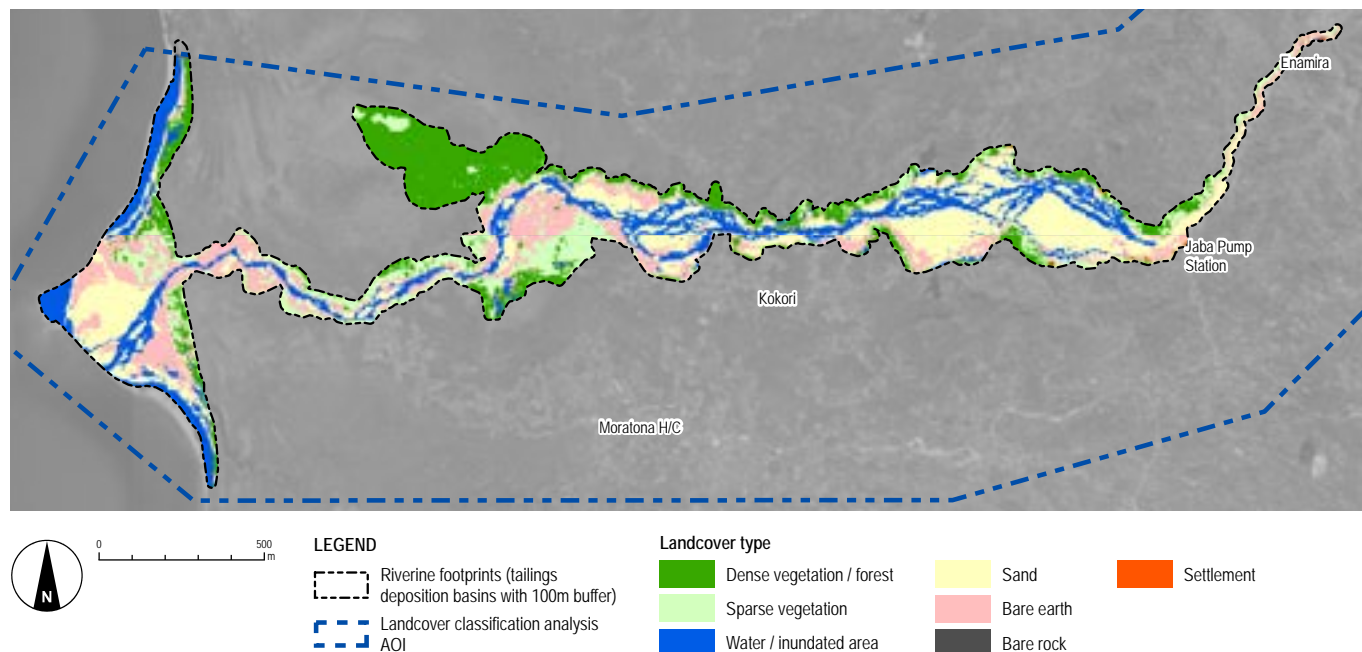
**Figure ES8** Landcover classification – Riverine footprint 1989

along the Jaba River, no tailings deposition in the area of dense vegetation north of the Jaba River downstream from Bato Bridge, no revegetation of the Jaba River Delta and very few settlements along the margins of the riverine footprint.

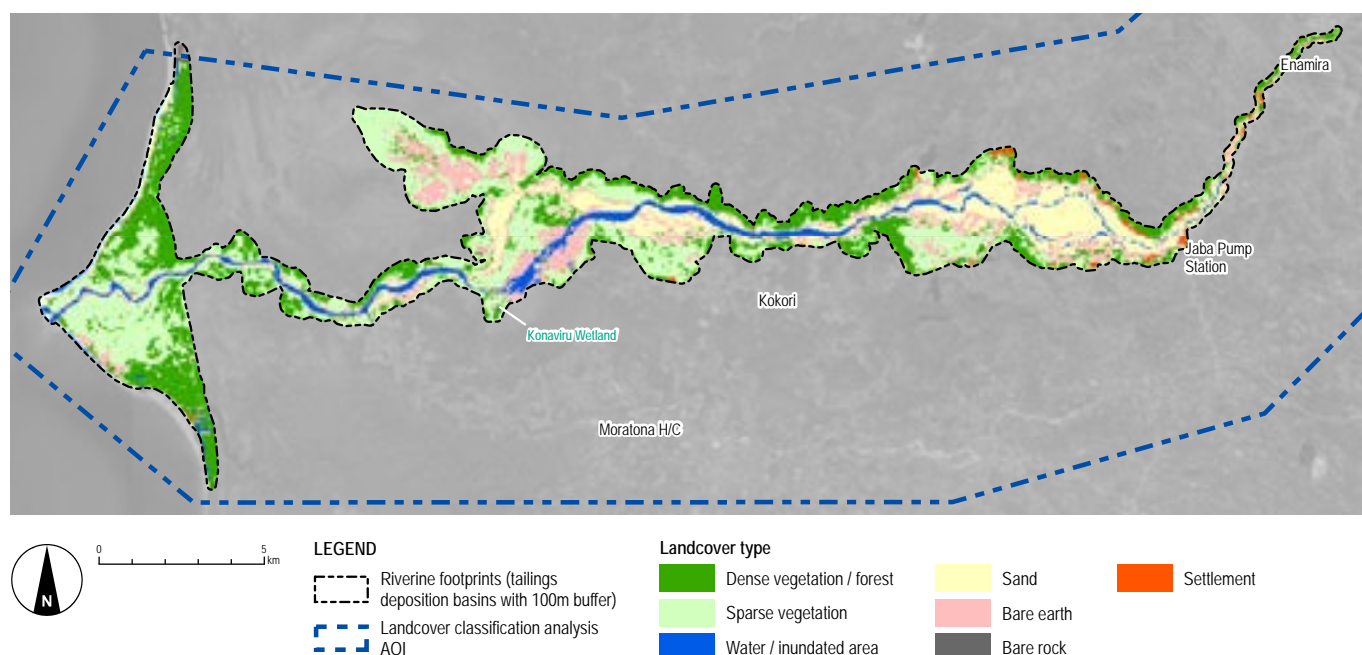
**Figure ES9** Landcover classification – Riverine footprint 2021

In comparison, Figure ES9 shows the landcover classification for the riverine area in 2021. This shows reduced areas of sand along the less braided river system with large areas that were sand in 1989 now being sparse or dense vegetation, conversion of the dense vegetation north of the Jaba River downstream from

Bato Bridge into sparse vegetation and bare earth due to the deposition of tailings in this area, the change in the course of the Jaba River through the Konaviru wetlands, revegetation of most of the Jaba River Delta and more settlements along the margins of the riverine footprint, particularly along the north and south of the edge of the river near the Jaba Pump Station.

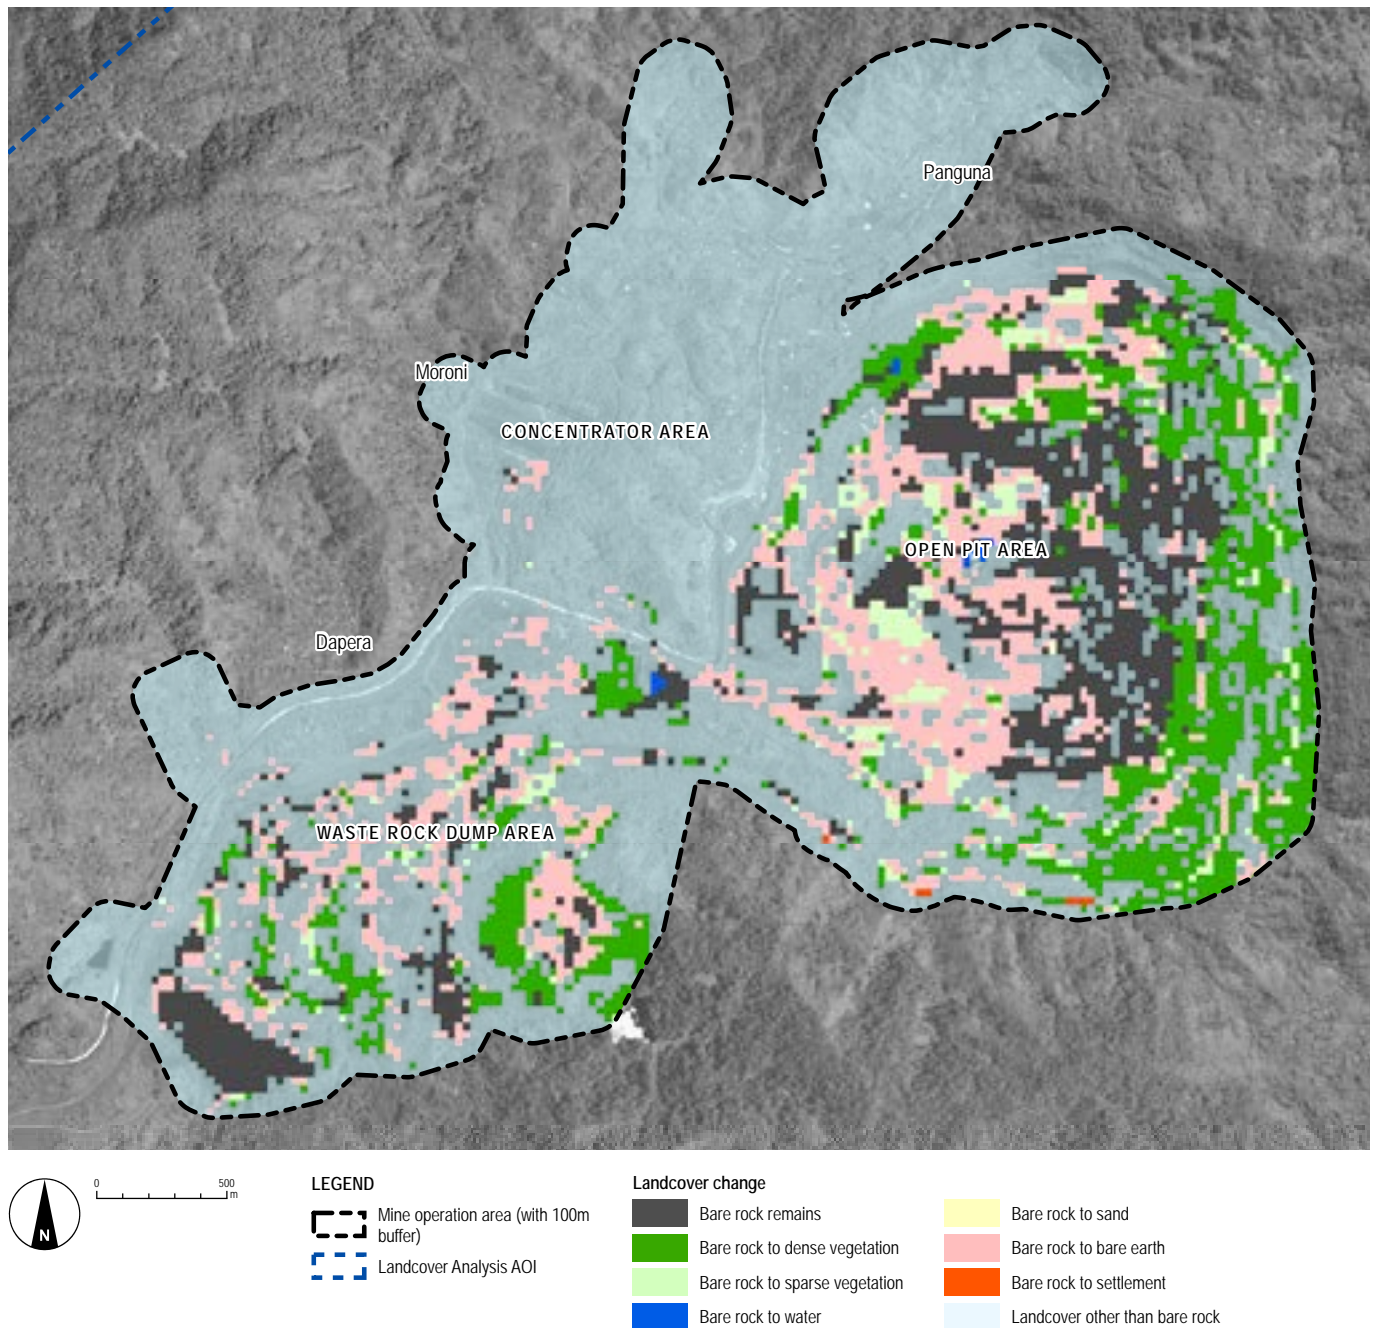
**Figure ES10** Change in bare rock from 1989 to 2021 (mine operation area)

Within the open pit, there is evidence of significant erosion, slope degradation, and compromised drainage systems.
