PANGUNA MINE LEGACY IMPACT ASSESSMENT PREPARATORY PHASE

Summary

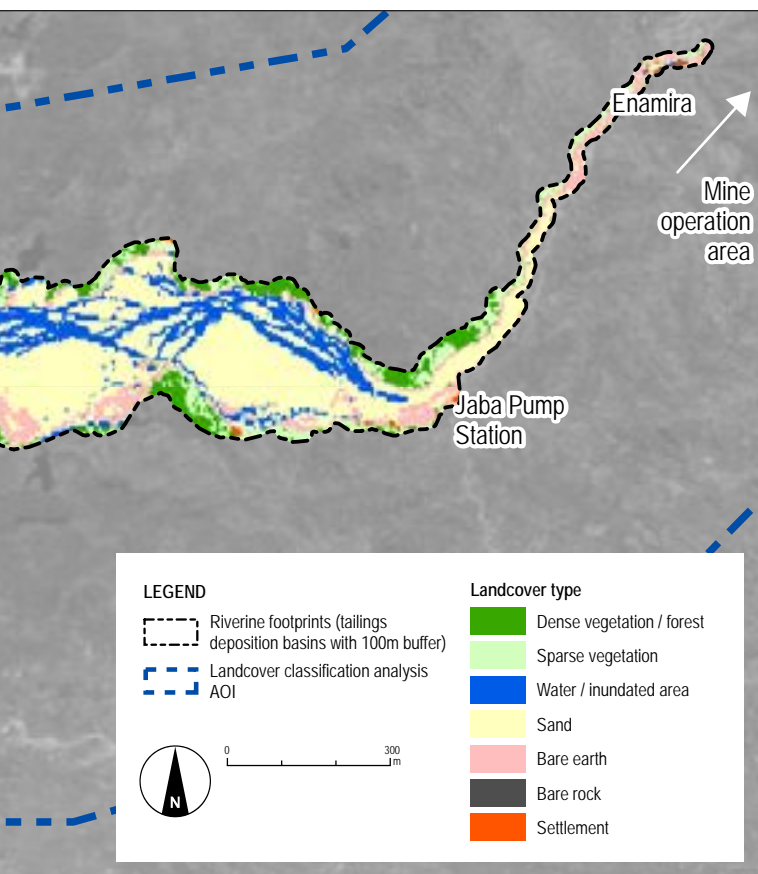
Figure 6 Landcover classification – Riverine footprint 2021

Figure 5 shows the landcover type for the riverine area in 1989. This shows large areas of sand (i.e., tailings) throughout the highly braided river system, little to no dense vegetation along the Jaba River, no tailings deposition in the area of dense vegetation north of the Jaba River downstream from Bato Bridge, no revegetation of the Jaba River Delta and very few settlements along the margins of the riverine footprint. In comparison, Figure 6 shows the landcover classification for the riverine area in 2021. This shows reduced areas of sand along the less braided river system with large areas that were sand in 1989 now being sparse or dense vegetation, conversion of the dense vegetation north of the Jaba River downstream from Bato Bridge into sparse vegetation and bare earth due to the deposition of tailings in this area, the change in the course of the Jaba River through the Konaviru wetlands, revegetation of most of the Jaba River Delta and more settlements along the margins of the riverine footprint, particularly along the north and south of the edge of the river near the Jaba Pump Station.
